LAWRENCE
LIVERMORE
NATIONAL
LABORATORY

LLNL-TR-648143

A Visual Description of the Concrete Exterior of the Cactus Crater Containment Structure

October 2013

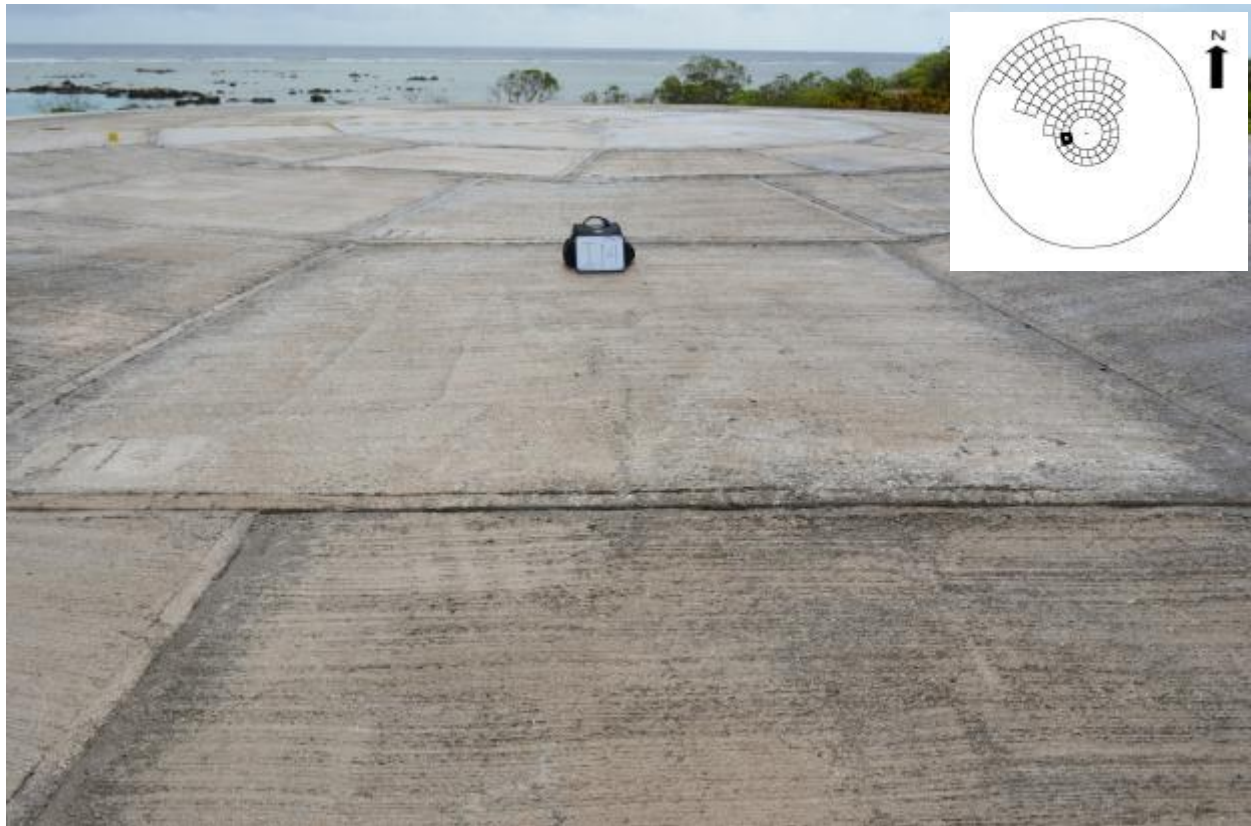
CAP SECTION LOCATION: Panel I14

No significant or obvious interior cracks or spall elements identified.

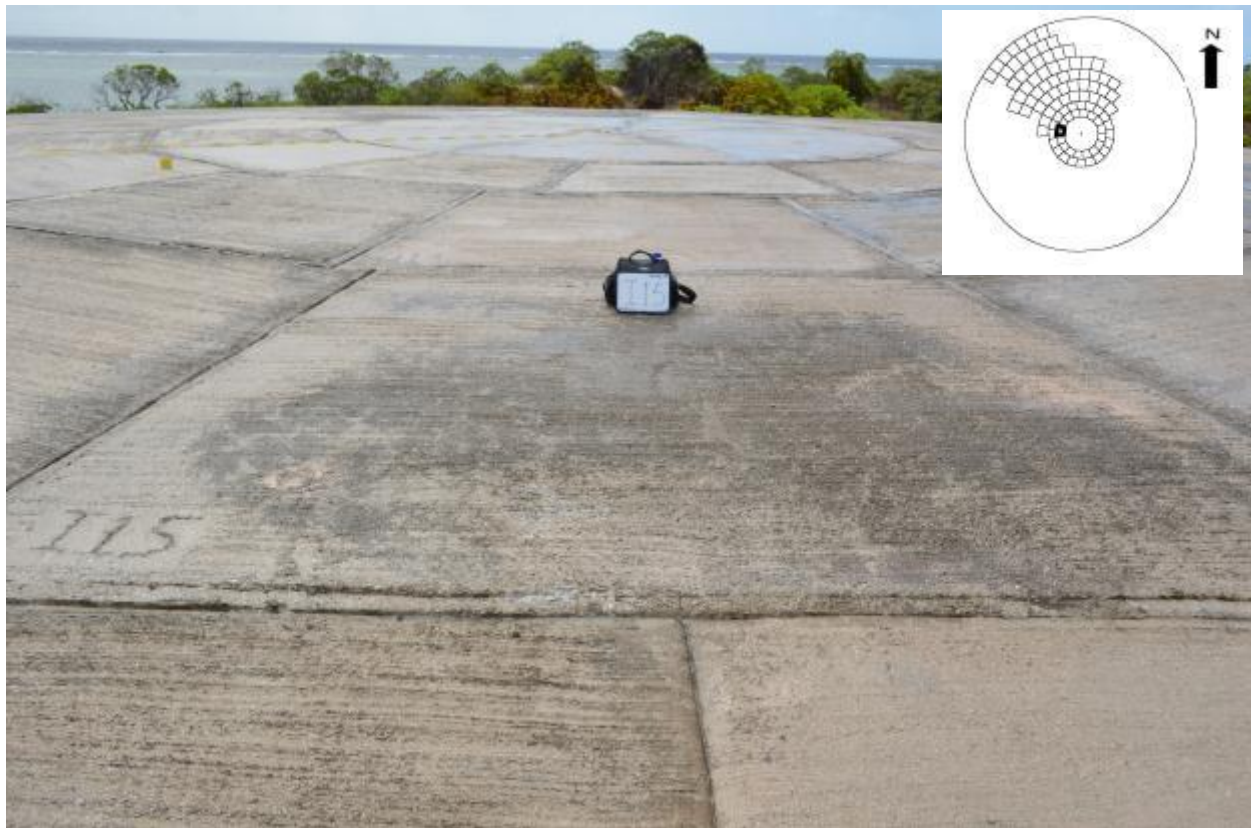
CAP SECTION LOCATION: Panel I15

No significant or obvious interior cracks or spall elements identified with exception of spalling/chipping of concrete in the left-hand corner of the panel. Panel contains a filled concrete bore-hole (CD-8) from the 1980 NAS investigation.

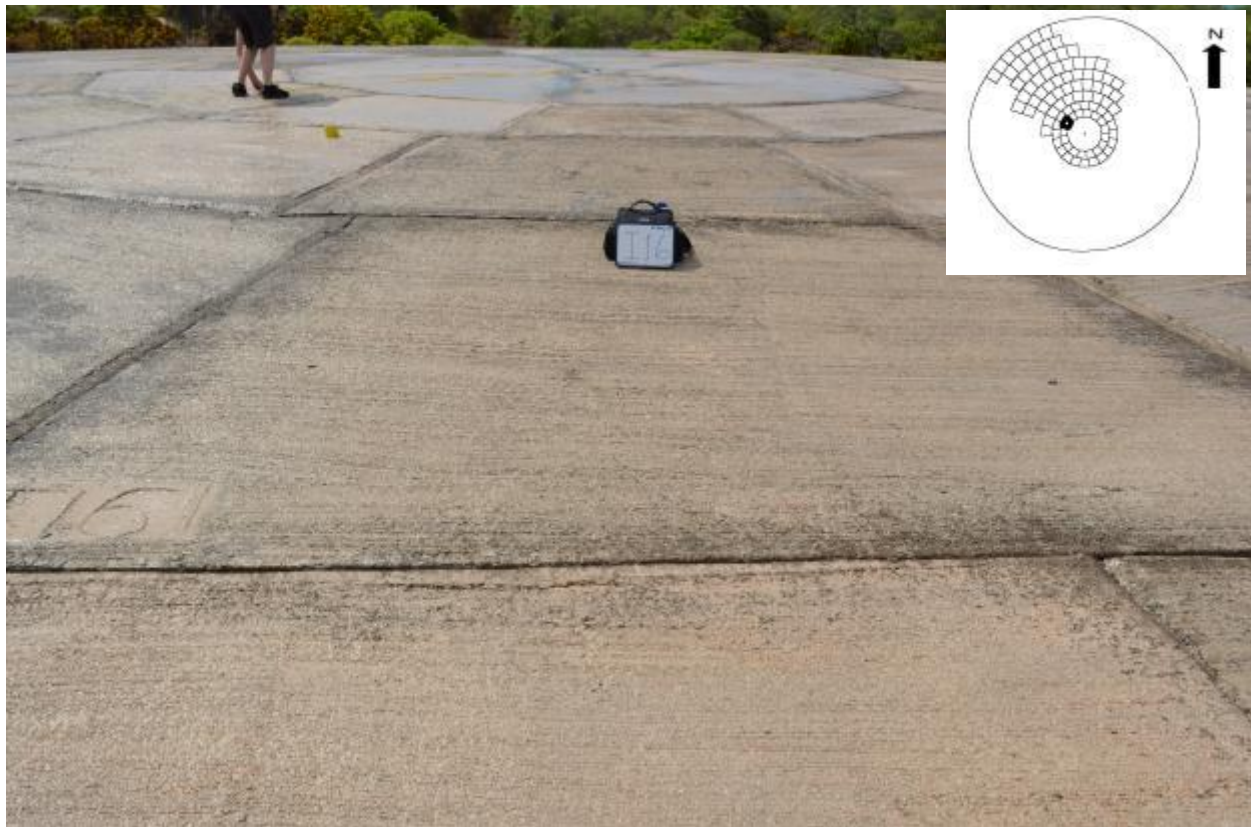
CAP SECTION LOCATION: Panel I16

No significant or obvious interior cracks or spall elements identified with exception of minor spalling/chipping of concrete in the left-hand corner of the panel.

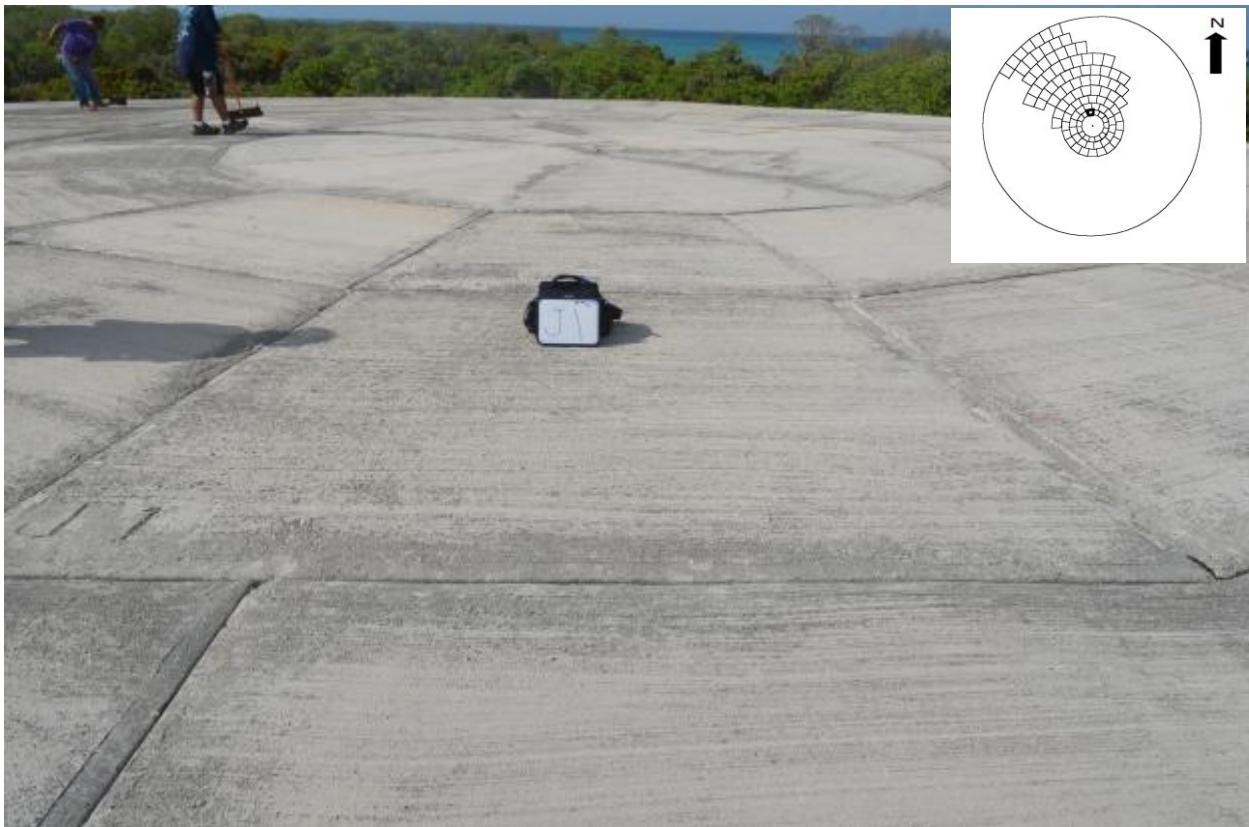
CAP SECTION LOCATION: Panel J1

No significant or obvious interior cracks or spall elements identified.

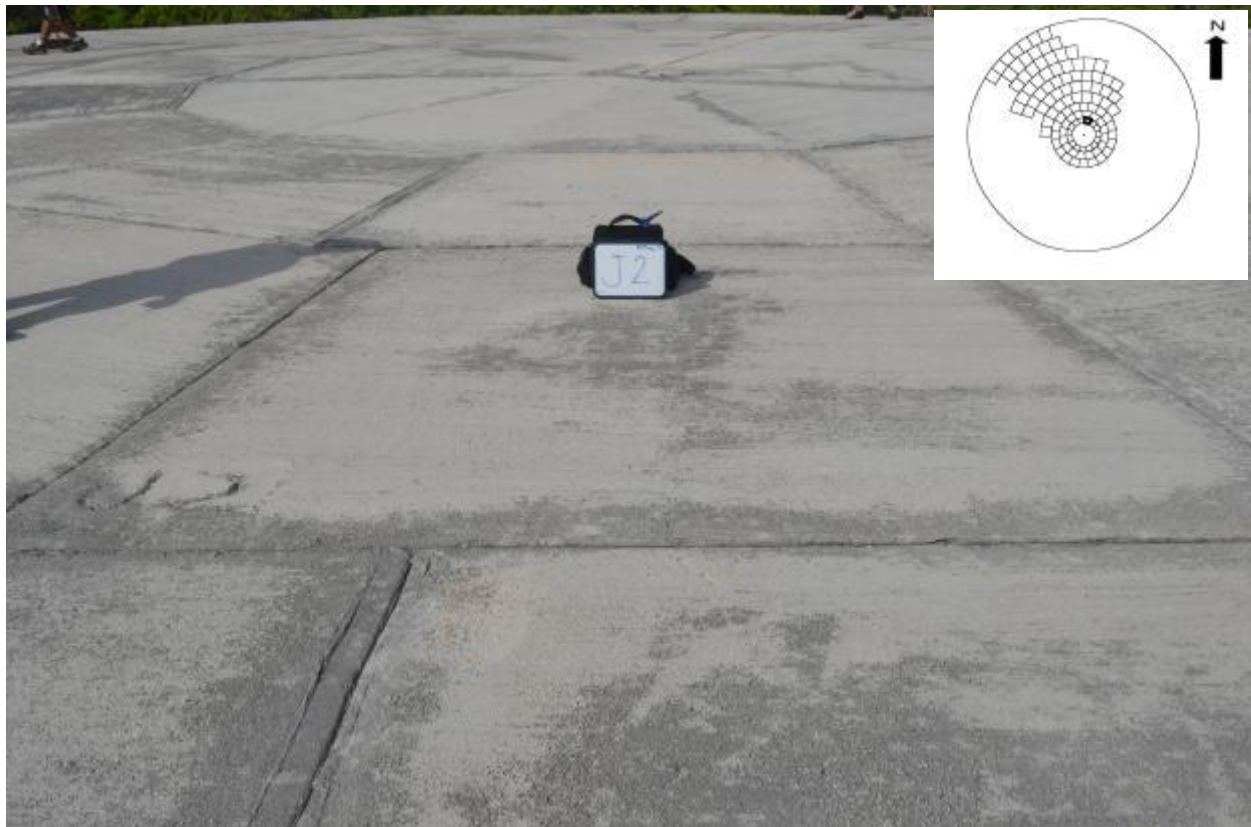
CAP SECTION LOCATION: Panel J2

No significant or obvious interior cracks or spall elements identified.

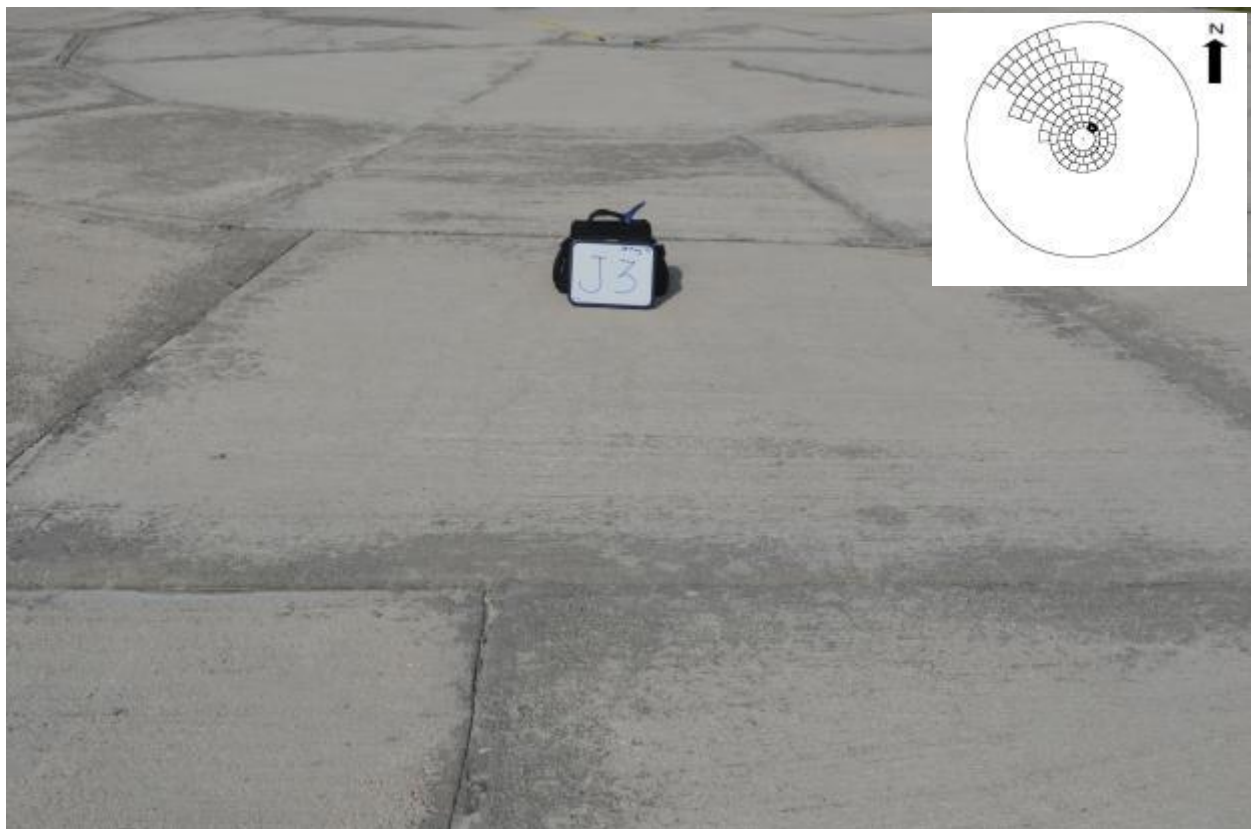
CAP SECTION LOCATION: Panel J3

No significant or obvious interior cracks or spall elements identified.

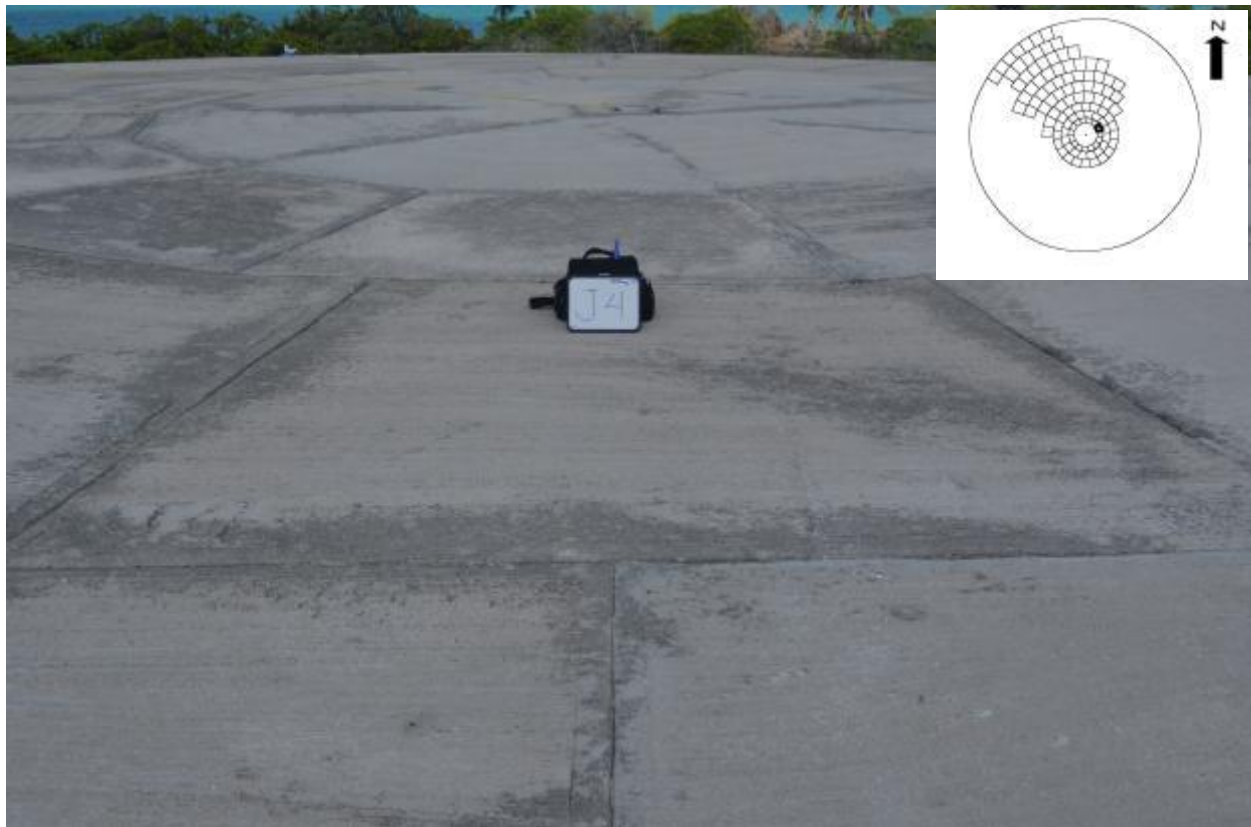
CAP SECTION LOCATION: Panel J4

No significant or obvious interior cracks or spall elements identified.

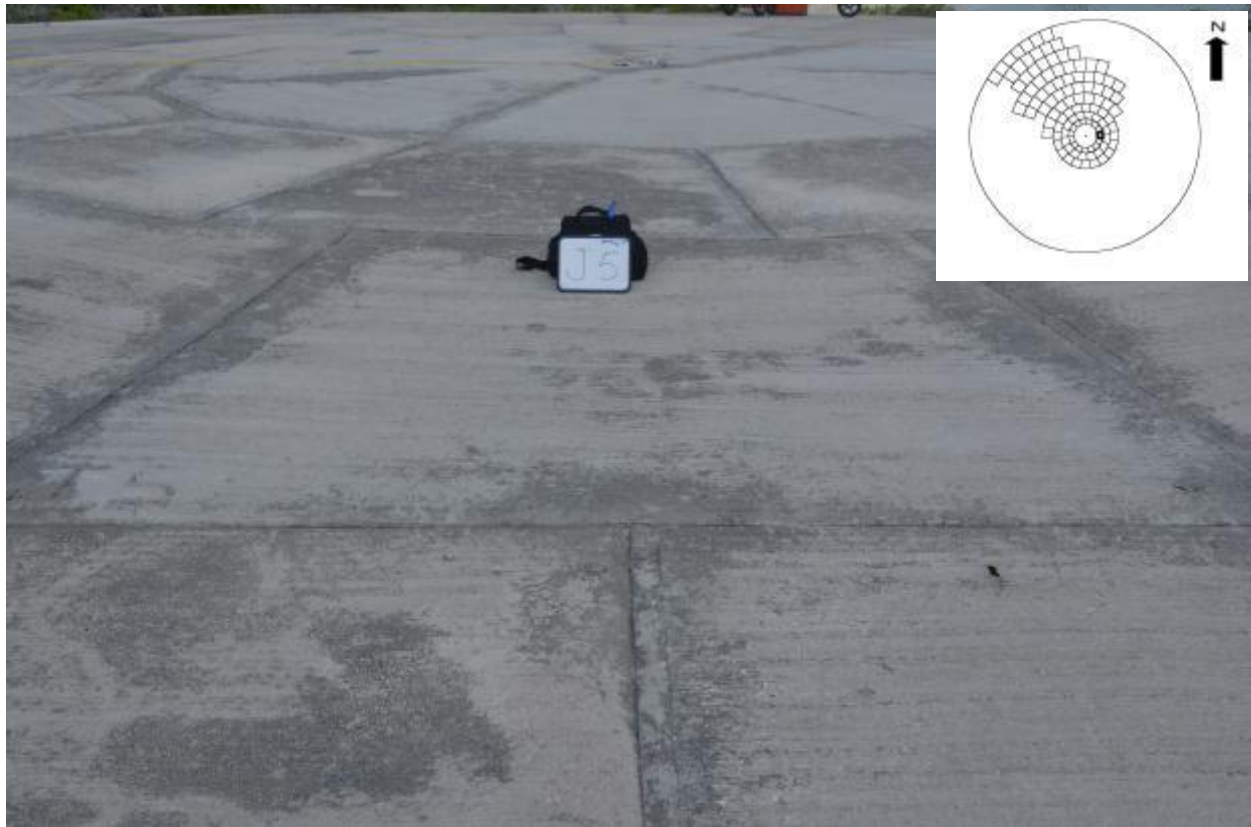
CAP SECTION LOCATION: Panel J5

No significant or obvious interior cracks or spall elements identified (no J6 panel present).

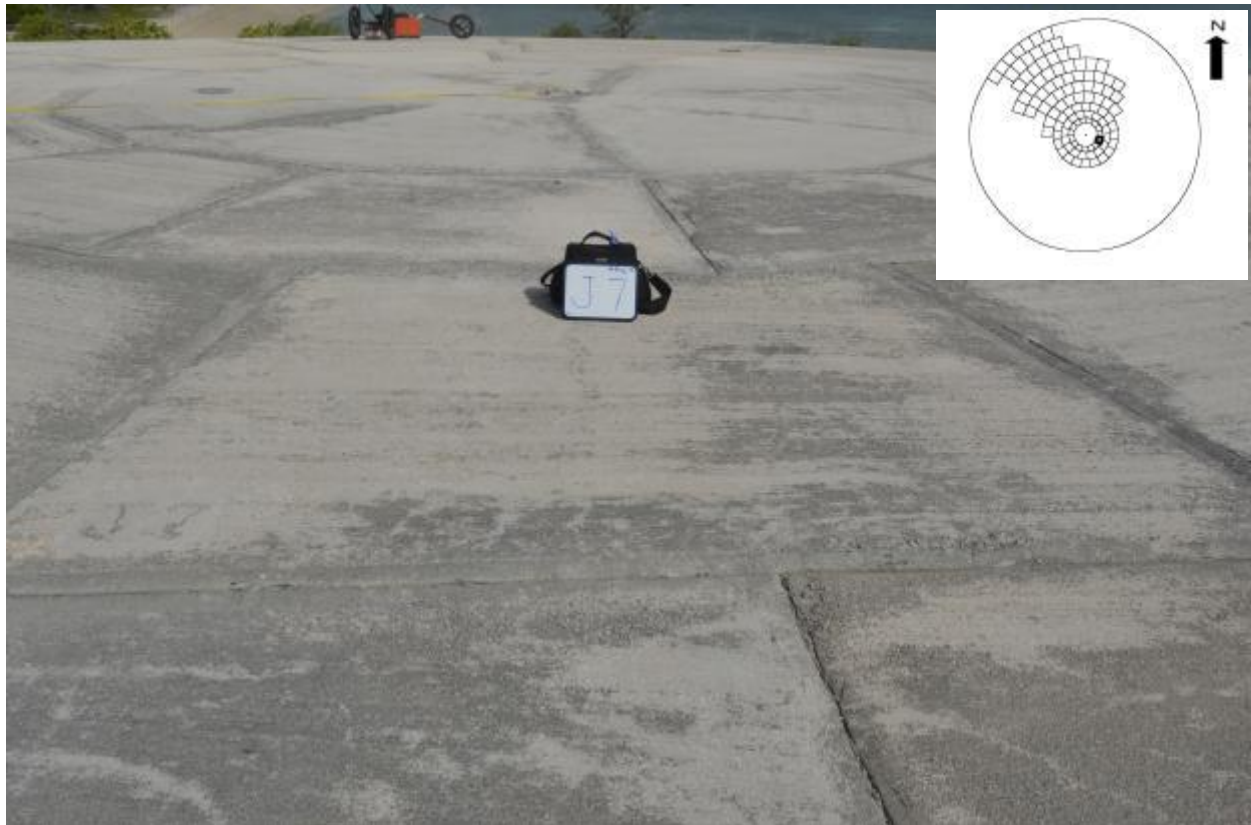
CAP SECTION LOCATION: Panel J7

No significant or obvious interior cracks or spall elements identified.

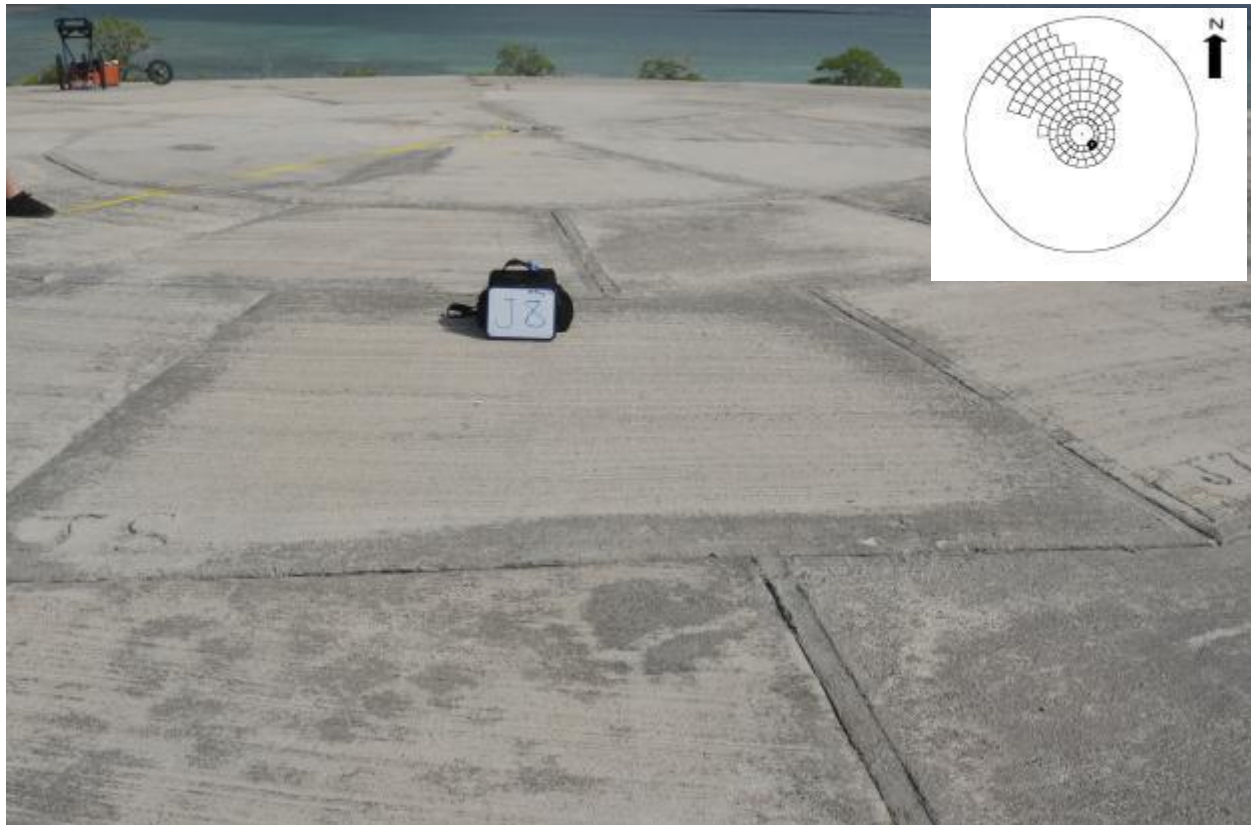
CAP SECTION LOCATION: Panel J8

No significant or obvious interior cracks or spall elements identified.

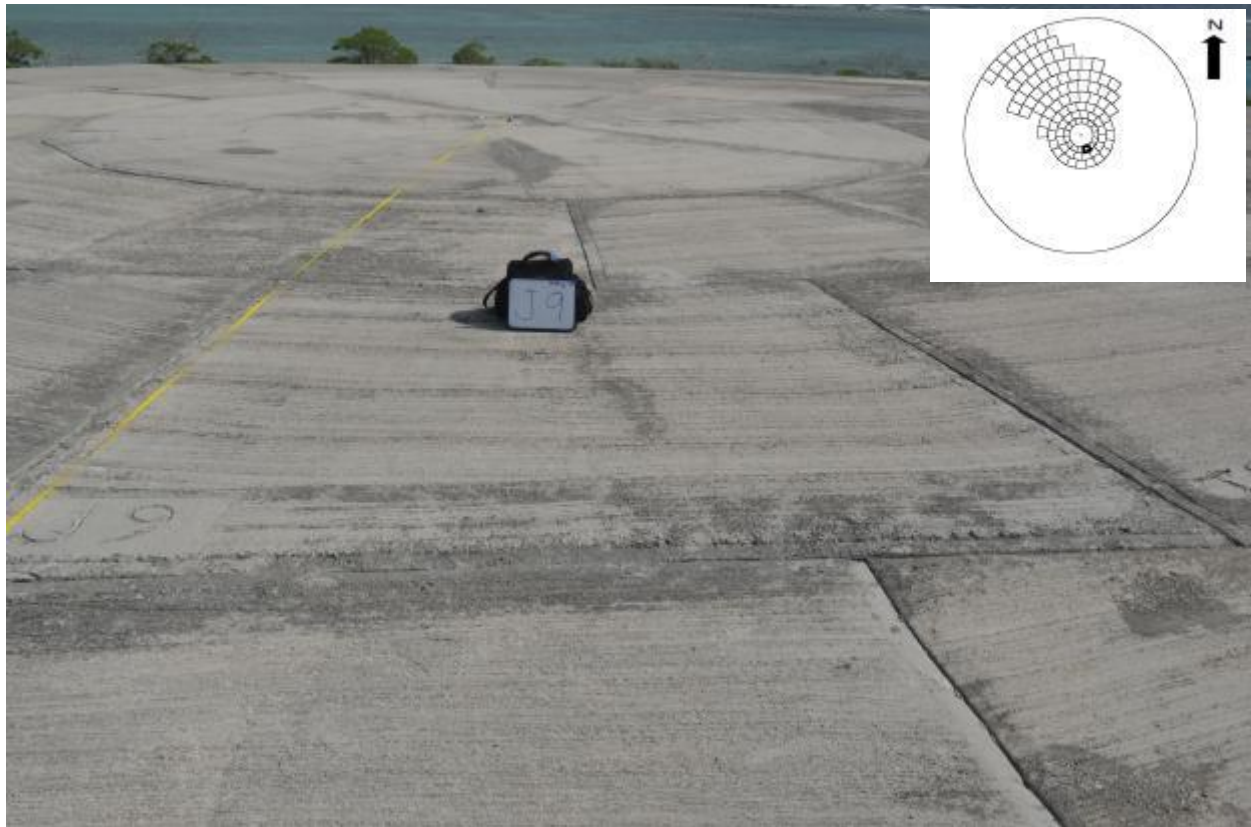
CAP SECTION LOCATION: Panel J9

No significant or obvious interior cracks or spall elements identified.

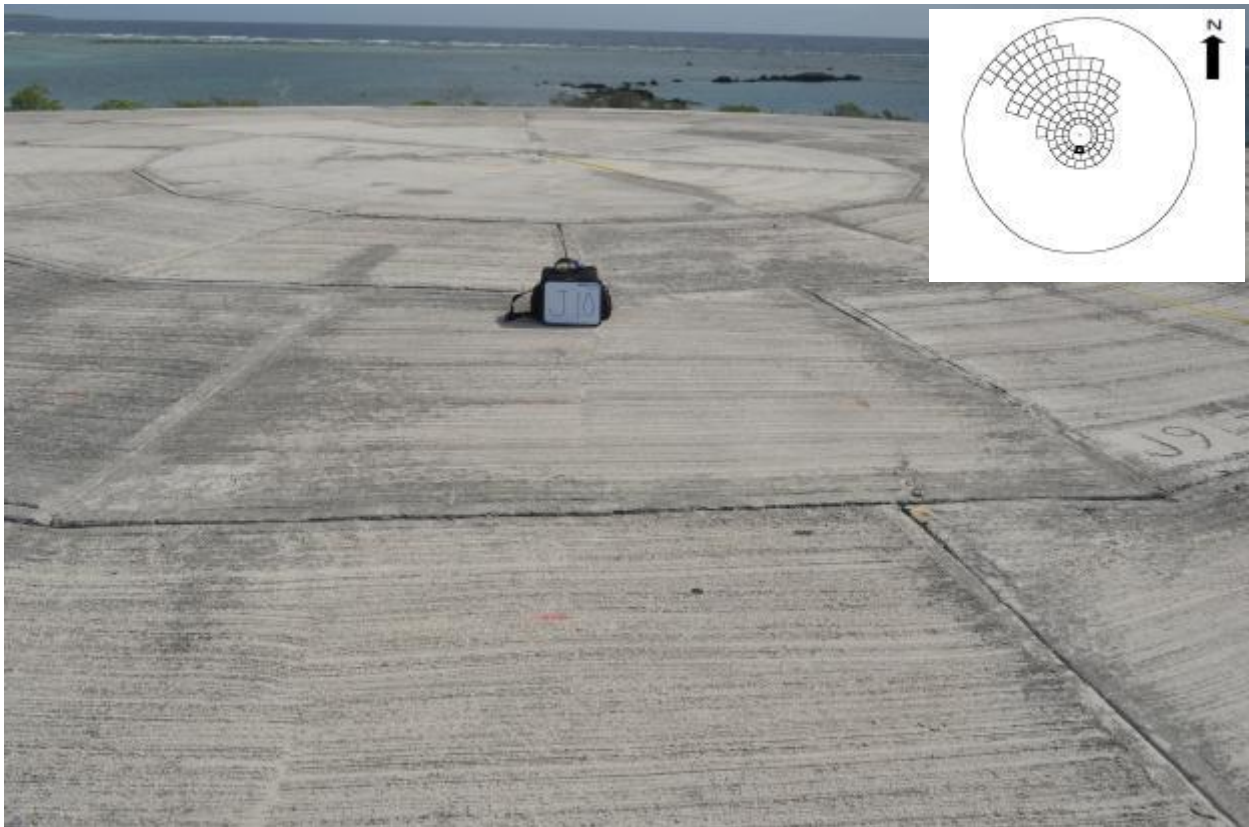
CAP SECTION LOCATION: Panel J10

Minor surface crack originating from the intersecting panel corners on the ring row below and traversing up and across the panel towards the upper right-hand corner.

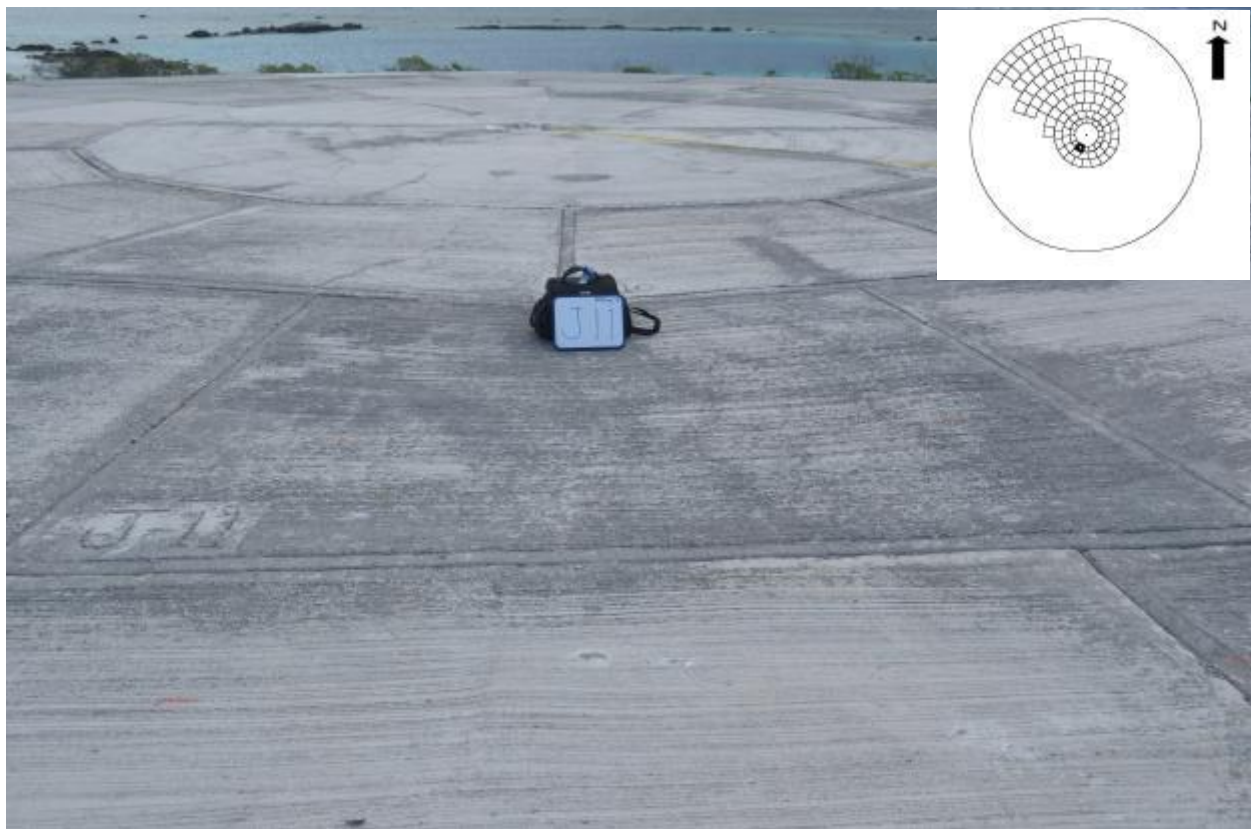
CAP SECTION LOCATION: Panel J11

No significant or obvious interior cracks or spall elements identified.

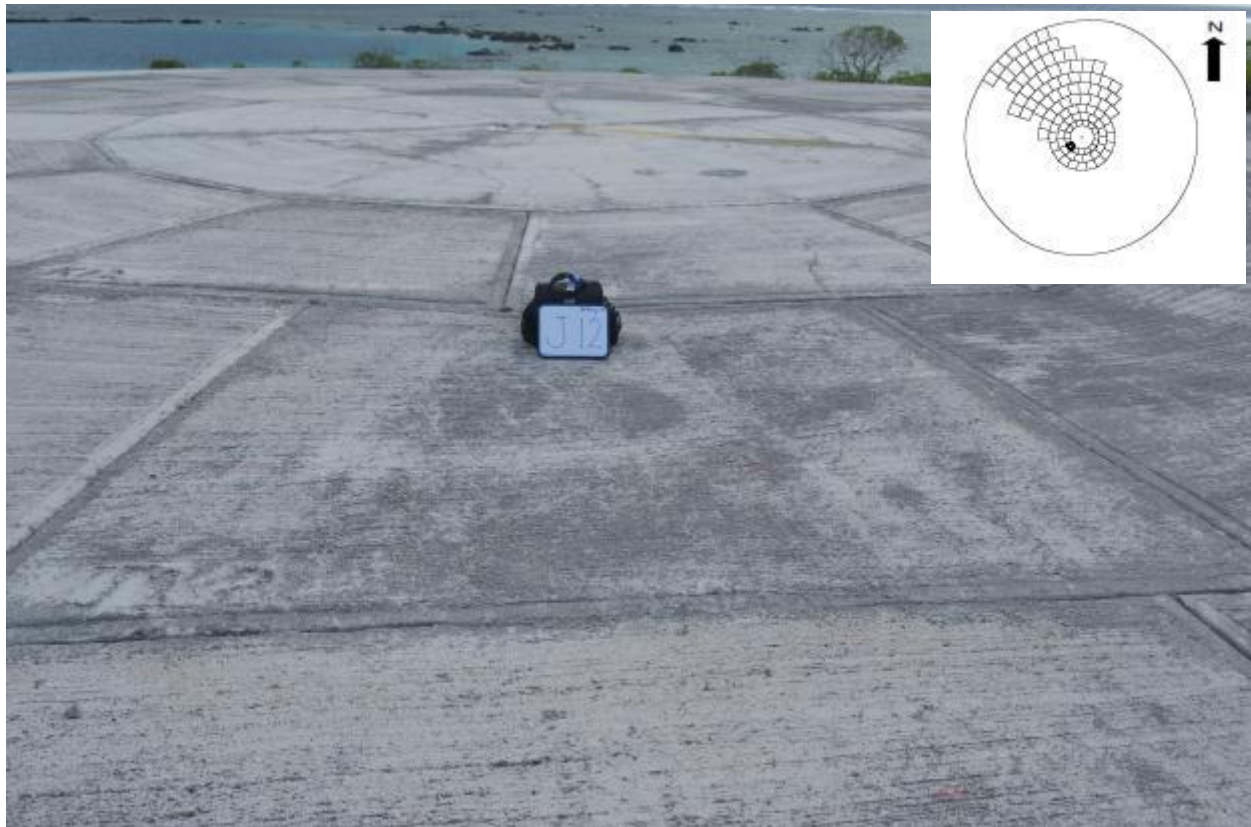
CAP SECTION LOCATION: Panel J12

No significant or obvious interior cracks or spall elements identified.

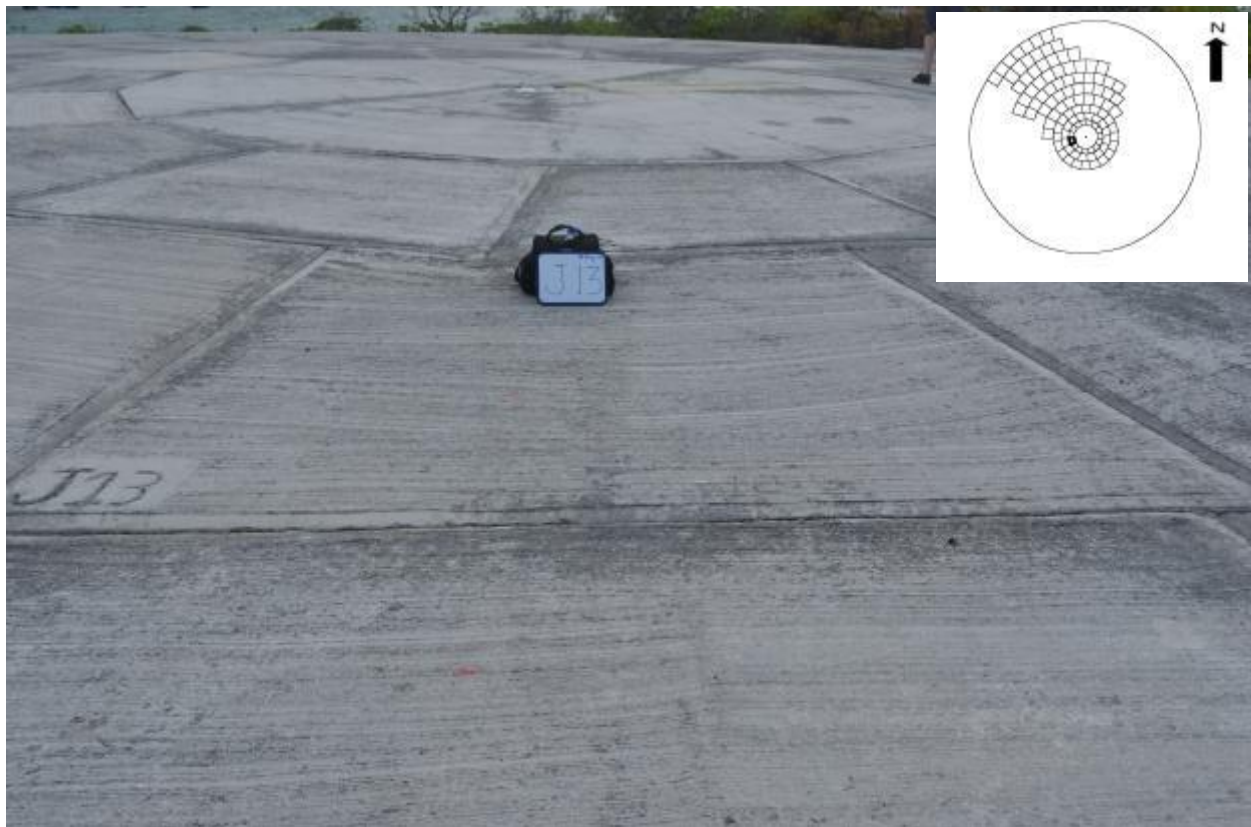
CAP SECTION LOCATION: Panel J13

No significant or obvious interior cracks or spall elements identified.

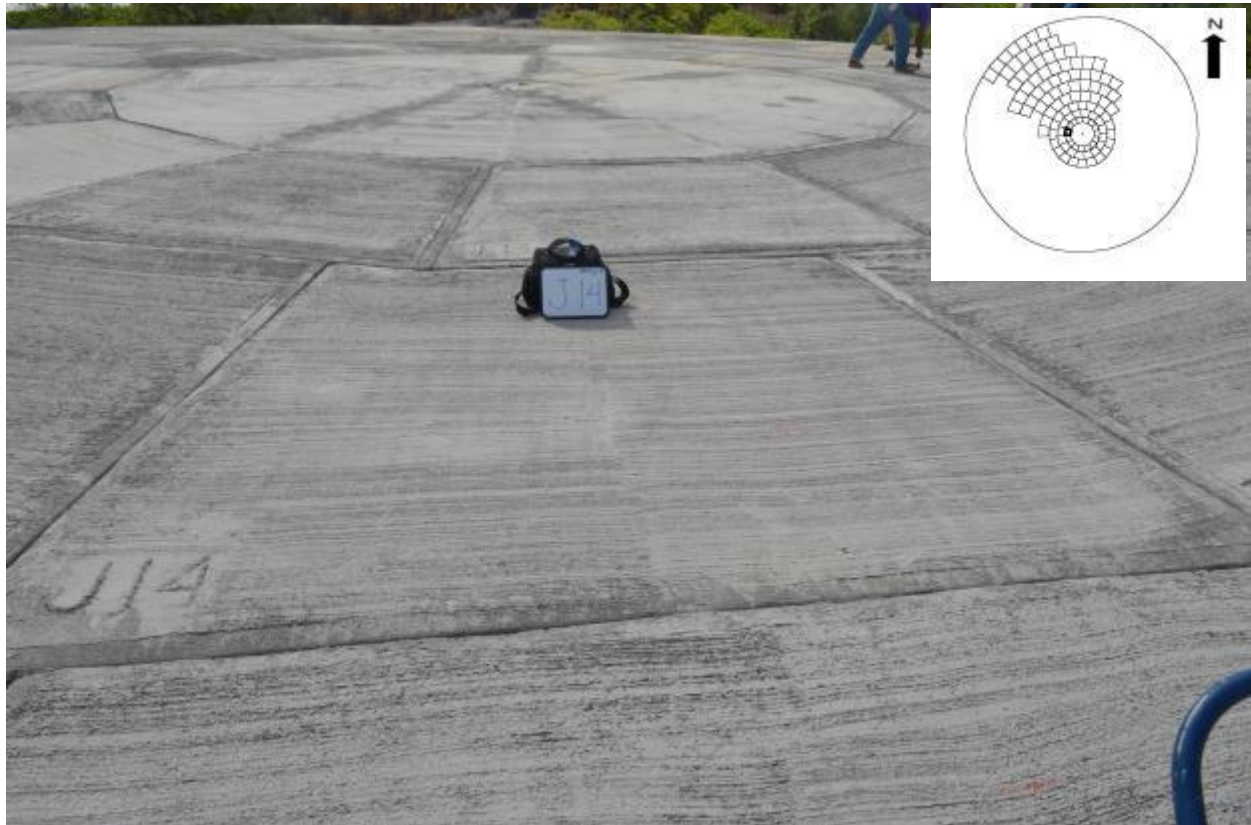
CAP SECTION LOCATION: Panel J14

No significant or obvious interior cracks or spall elements identified.

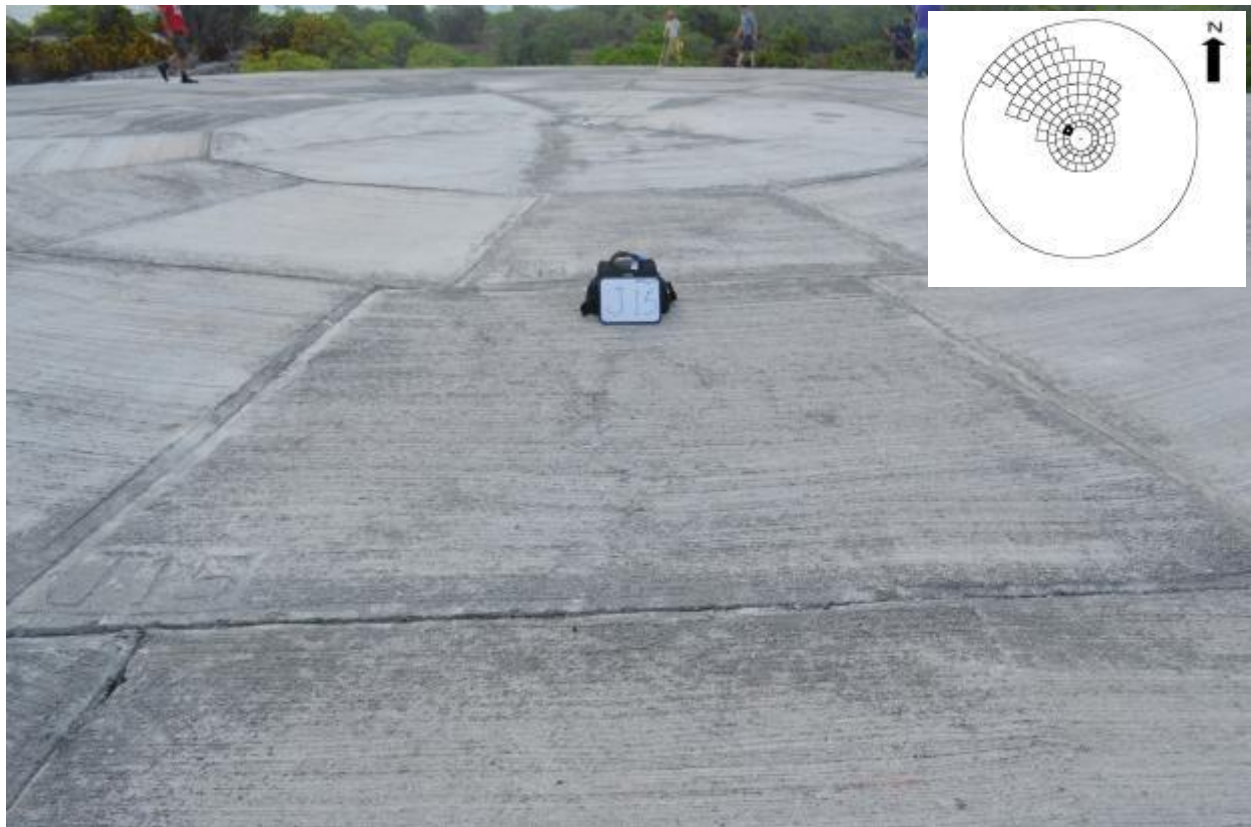
CAP SECTION LOCATION: Panel J15

No significant or obvious interior cracks or spall elements identified with exception of very minor spalling of concrete along the left side of the upper seam.

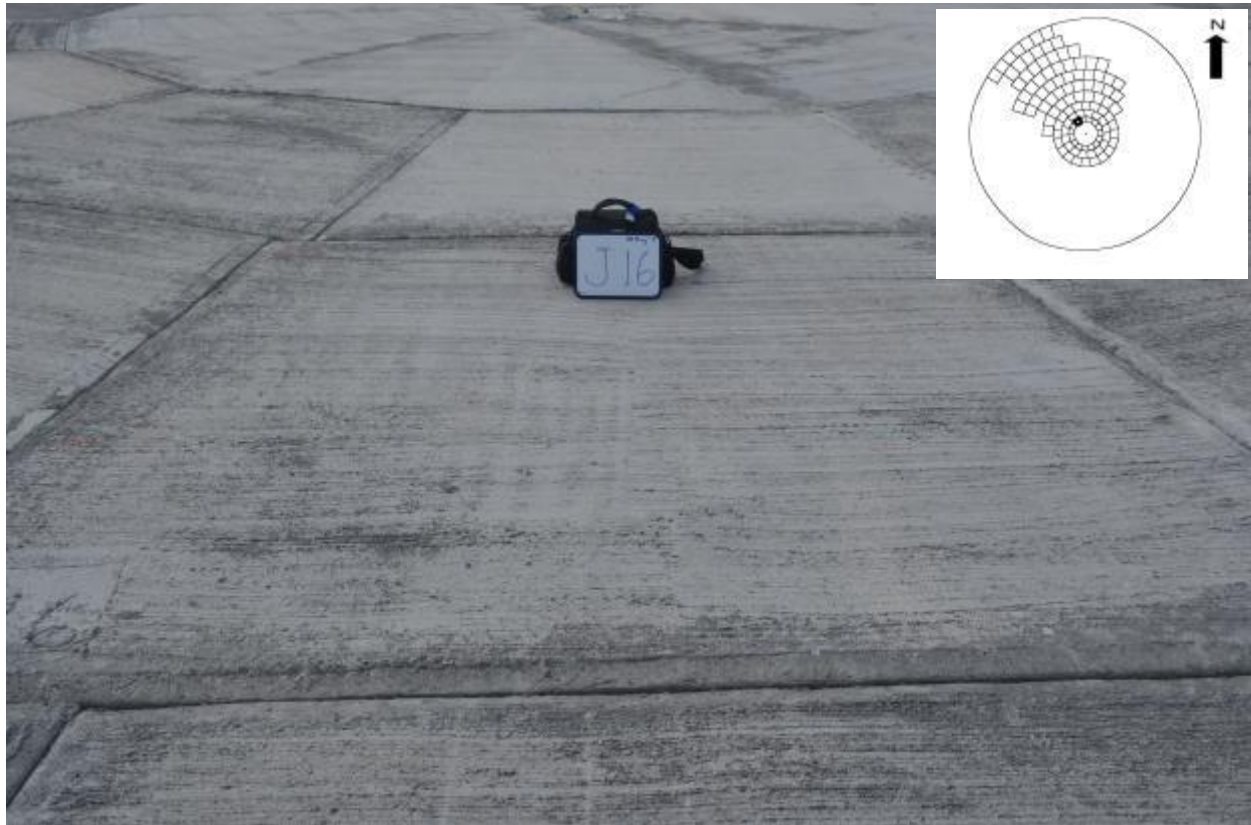
CAP SECTION LOCATION: Panel J16

No significant or obvious interior cracks or spall elements identified with exception of very minor spalling of concrete along the seams.

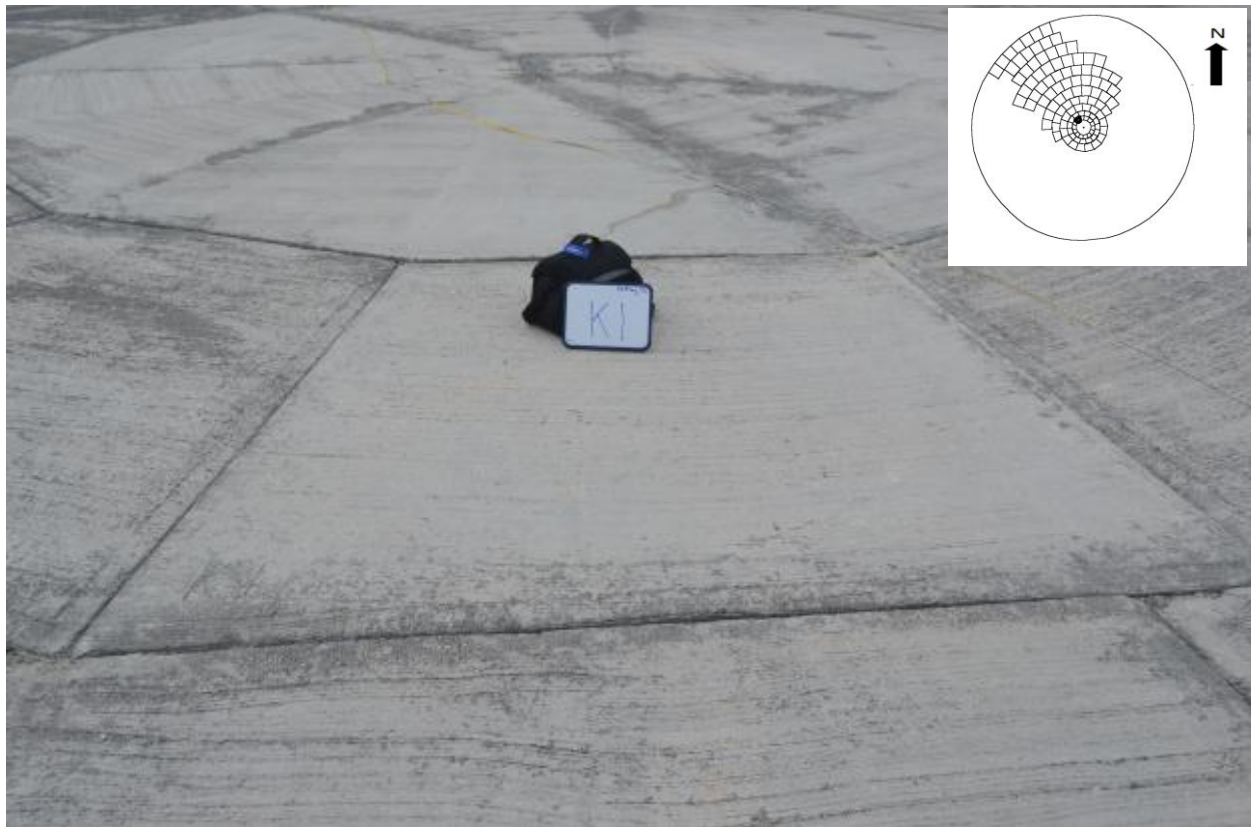
CAP SECTION LOCATION: Panel K1

No significant or obvious interior cracks or spall elements identified. Some very minor spalling/cracking observed in the upper right corner.

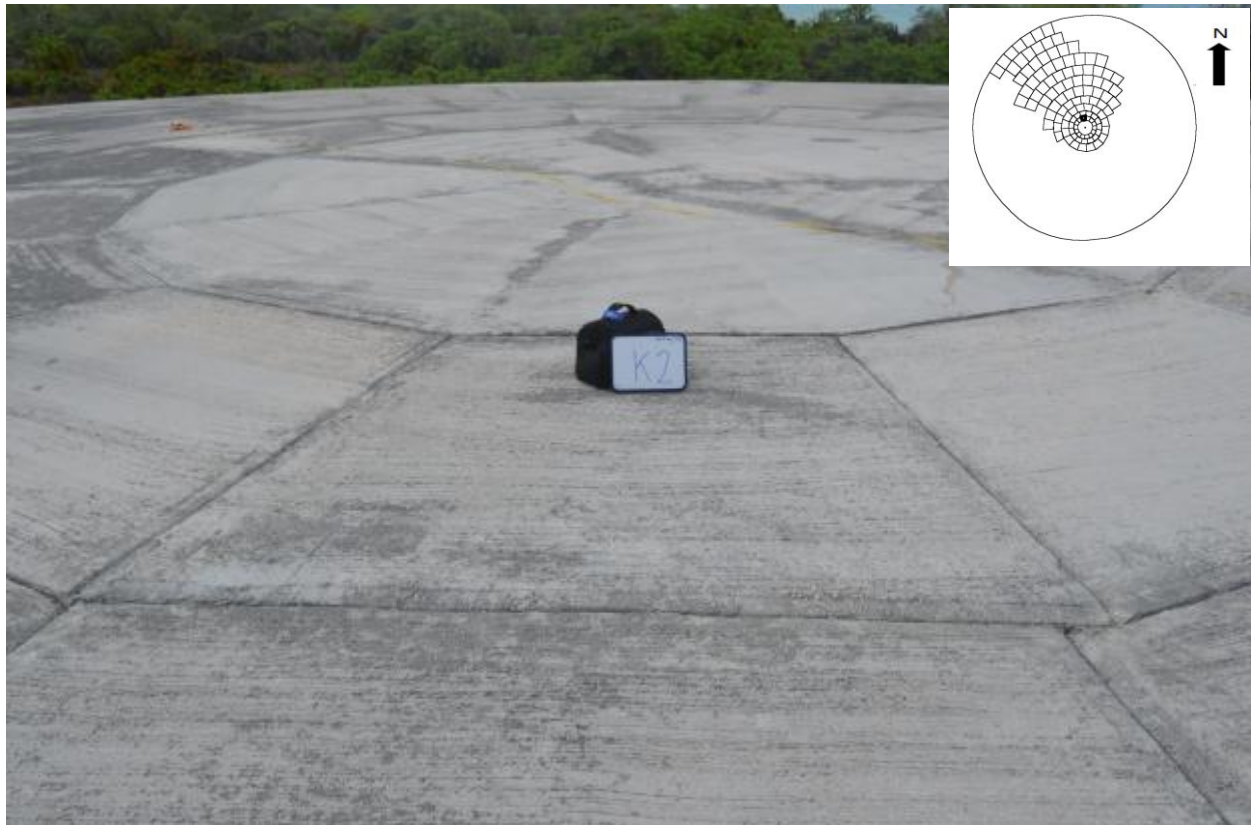
CAP SECTION LOCATION: Panel K2

No significant or obvious interior cracks or spall elements identified.

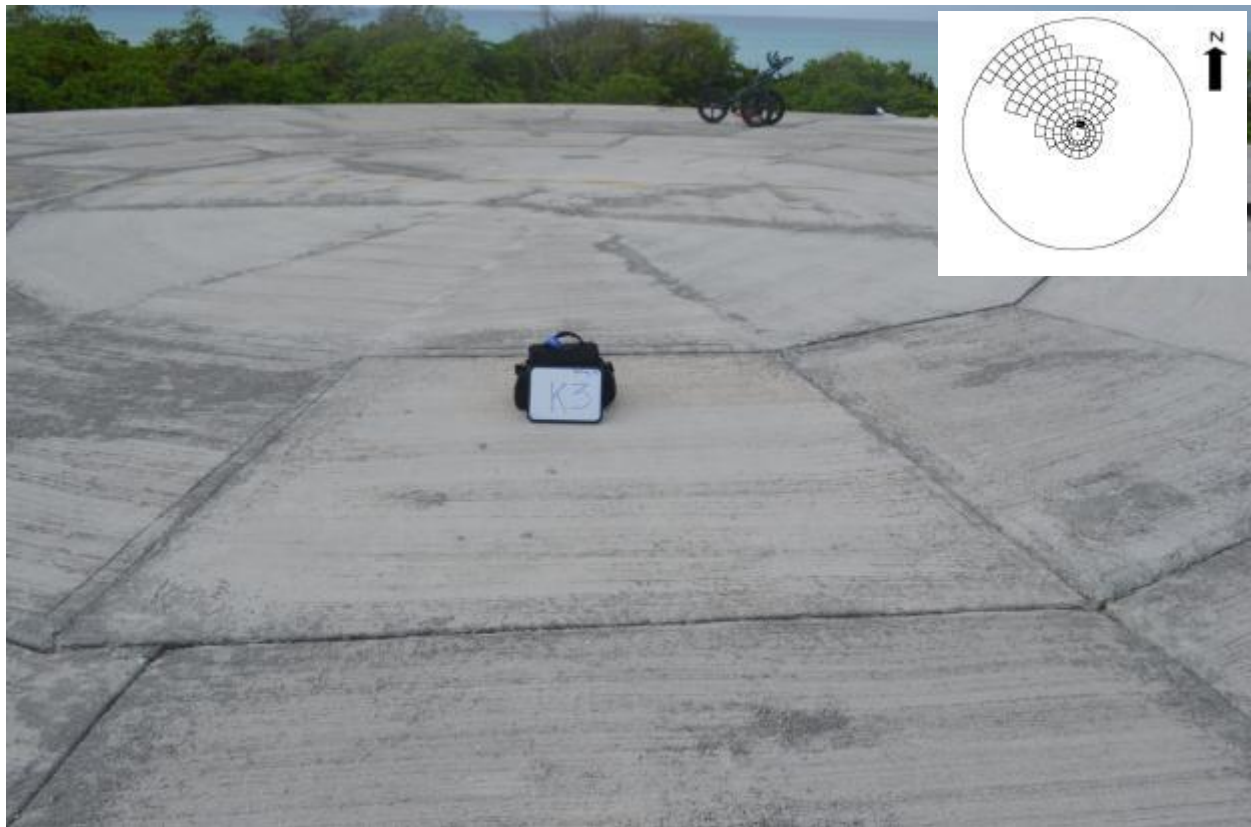
CAP SECTION LOCATION: Panel K3

No significant or obvious interior cracks or spall elements identified.
